M5 Motorway repair completed with minimal lane closure time

The SAFETRACK® Crack Infill system reinstates and protects M5 Motorway

Project	M5 Motorway
Client	Balfour Beatty Mott Macdonald
GCP Solutions	The SAFETRACK® Crack Infill system

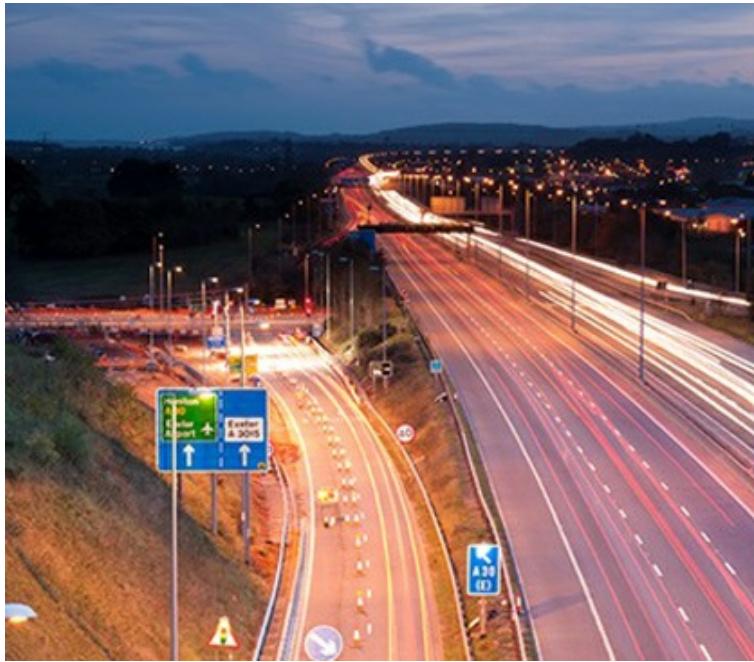
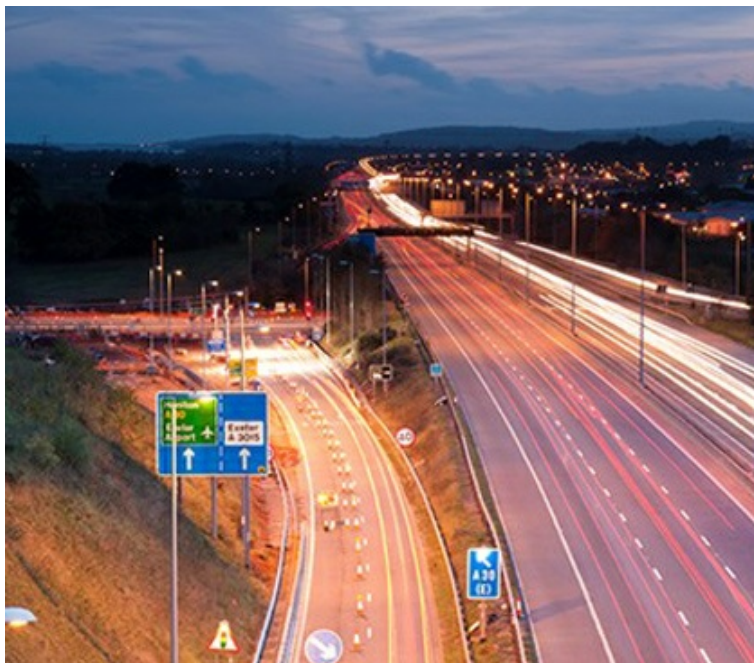
The team used SAFETRACK[®] Crack Infill with a revolutionary new machine application process that is safer, more efficient and more cost effective than traditional techniques. Using this process on the M5, the joint was prepared and then filled and sealed with the SAFETRACK[®] Crack Infill.

The works were carried out over eight night time closures of the road, leaving an eight hour window to set out the traffic management, prepare the crack, apply the SAFETRACK[®] Crack Infill system and remove the traffic control. The fast curing time of the system enabled approximately 1,000 linear metres per hour to be treated. In addition, the rapid cure of the bespoke resin meant that application could continue up to 30 minutes before the traffic management was due to be removed, and the road returned to full traffic load just 30 minutes later.
