M8 Motorway slip road repaired and protected for the long term

SAFETRACK® Inlaid Road Repair prevents water ingress

Project	M8 Motorway Slip Road
Client	Transport Scotland
Contractor	LMS Highways
GCP Solutions	SAFETRACK® Inlaid Road Repair

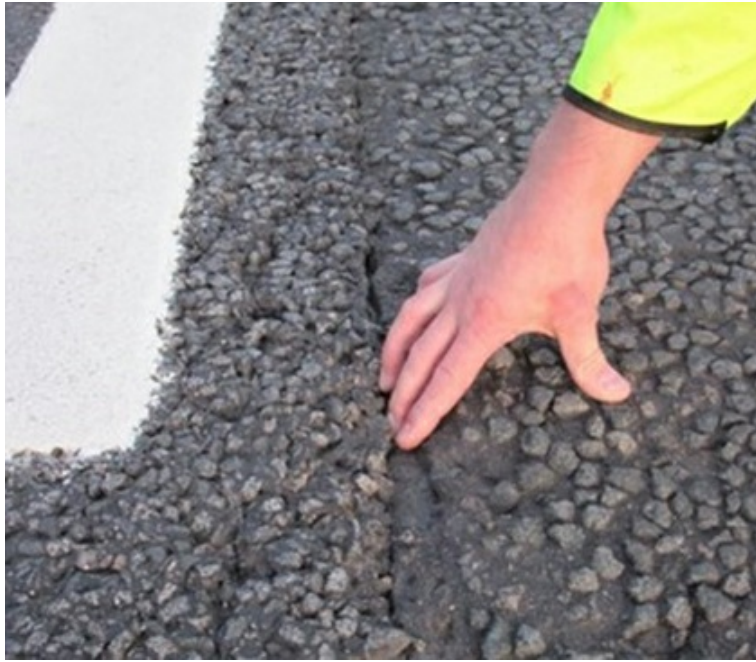
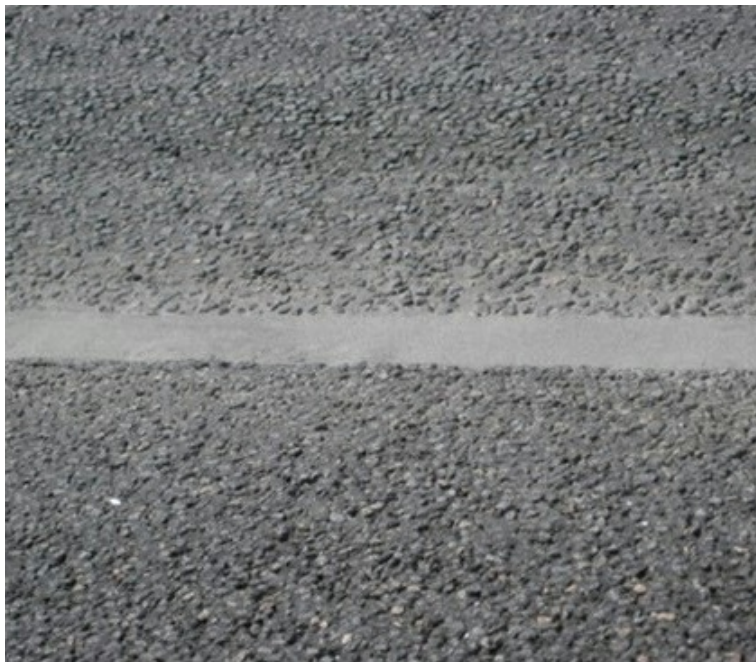
The fretted joints of the M8 needed repairing and sealing to prevent water ingress and further damage to the otherwise sound asphalt. The repair also needed to be strong enough to cope with high volume heavy goods vehicle traffic and the additional loads created by acceleration/declaration and transverse loading across the joint during lane changes.

The client selected the HAPAS-approved **SAFETRACK**[®] Inlaid Road Repair system, developed by Stirling Lloyd (now GCP Applied Technologies). A micro milling technique was also developed to reduce the amount of asphalt milled from the surface prior to inlaying the repair system. Based on unique **ESSELAC**[®] technology, the **SAFETRACK**[®] repair systems includes a unique resin that enables a thinner recessed repair to be achieved than would be possible with a traditional asphalt-based material. Less milling and less materials applied increases the speed of application and reduces cost and disruption.

The system's rapid cure meant that the road could be returned to full traffic load in as little as half an hour after installation, since there was no residual heat to be lost from the system. The system enabled more than 200 linear meters of fretted joint to be repaired per hour.
